SOIL EROSION STABILIZATION IN KINARUT PROJECT

Reported by:
Jazah Saman
Plantation Officer, SAFODA

JULY 1992

**Sabah Re-Afforestation Technical Development
And Training Project**

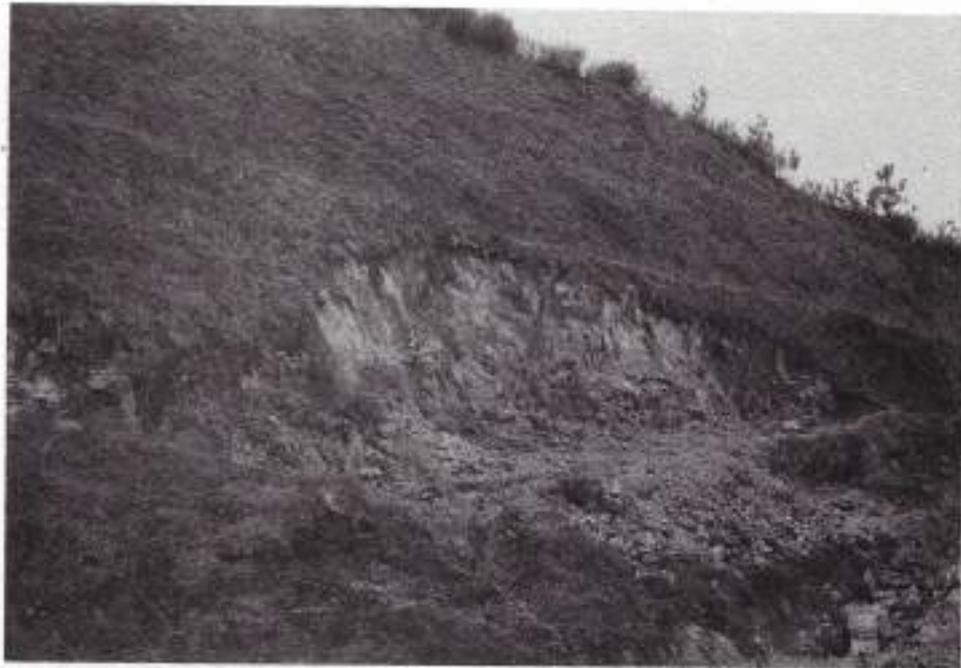
Situation 1. Landslide of a terraced cut slope. (Picture 1).

Possible cause: Gravitational erosion combined with water erosion.

The landslide area was repaired using gunny sacks filled with soil and wire for stitching. In the first stage of repair, the damaged section was levelled using handtools such as scoop and hoe. (See Picture 2)

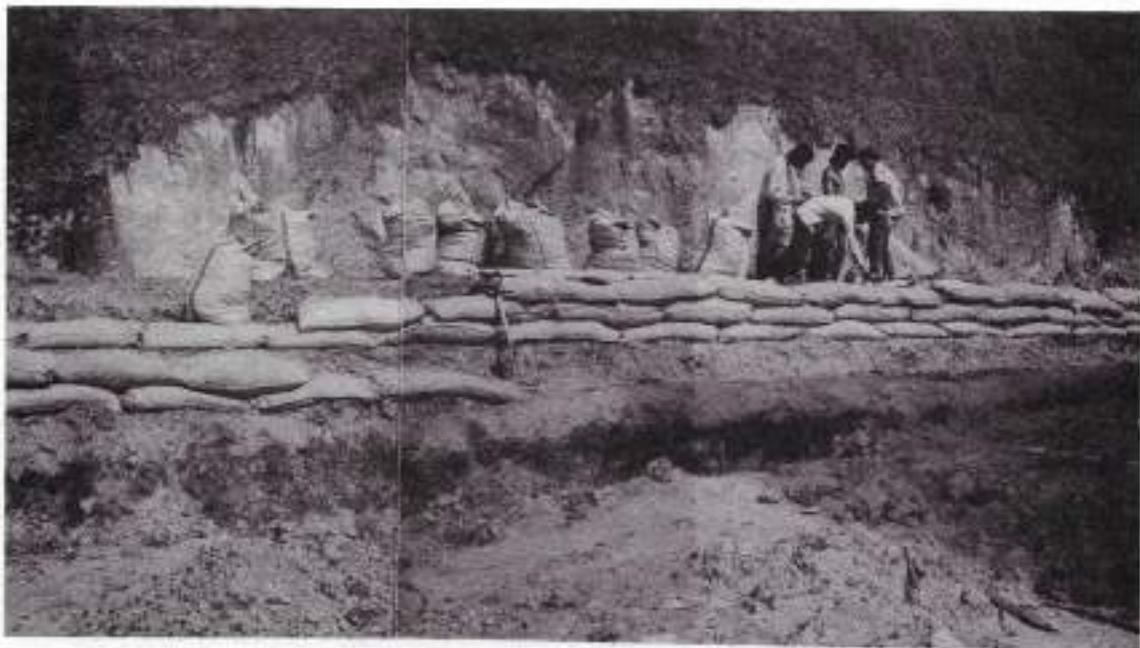
Gunny sacks were filled with soil and the opened section of the sacks were stitched with wire. Filled gunny sacks are arranged as shown in Picture 3 (brick-wall arrangement).

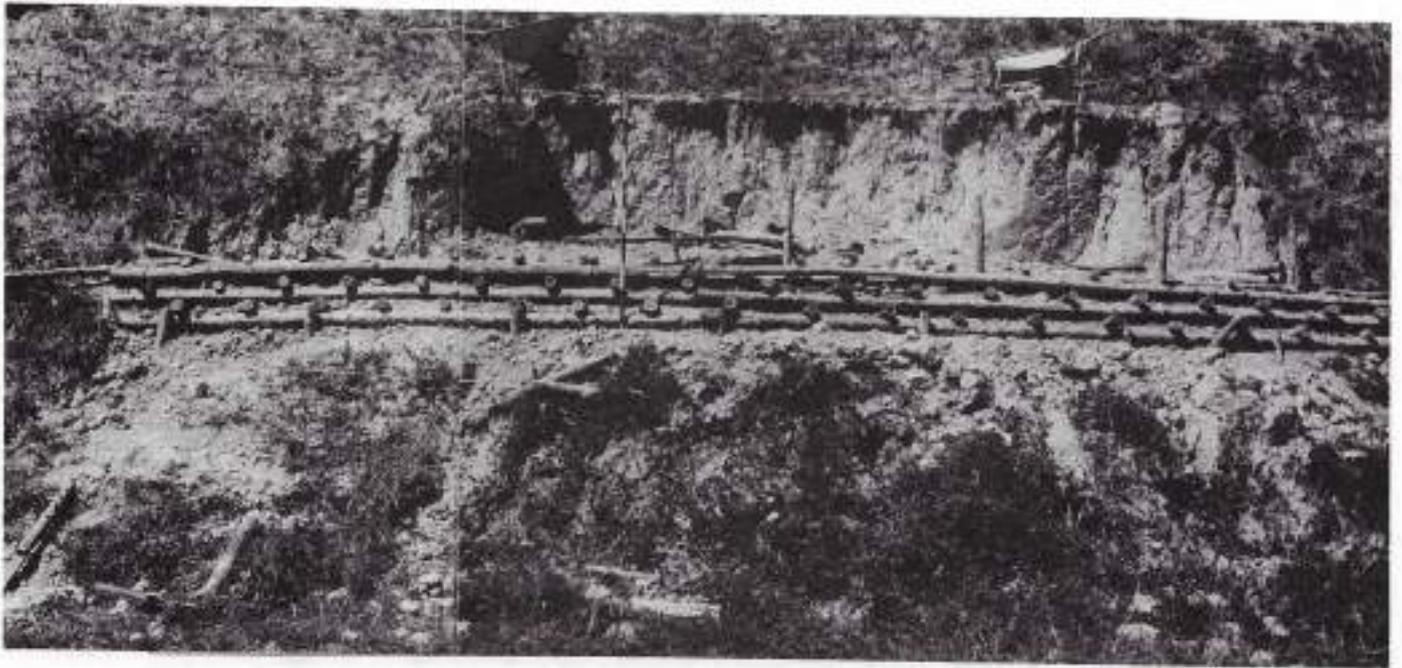
Situation 2. Landslide of a terraced cut slope. (Picture 7).

Possible causes : Gravitational erosion combine with water erosion.

This damaged area was repaired using log retaining wall. For complete information about this log retaining wall design refer to the *Manual of Forest Road Maintenance and Soil Erosion Control* by Jazah Saman and Takeshi Nakamura (1991).

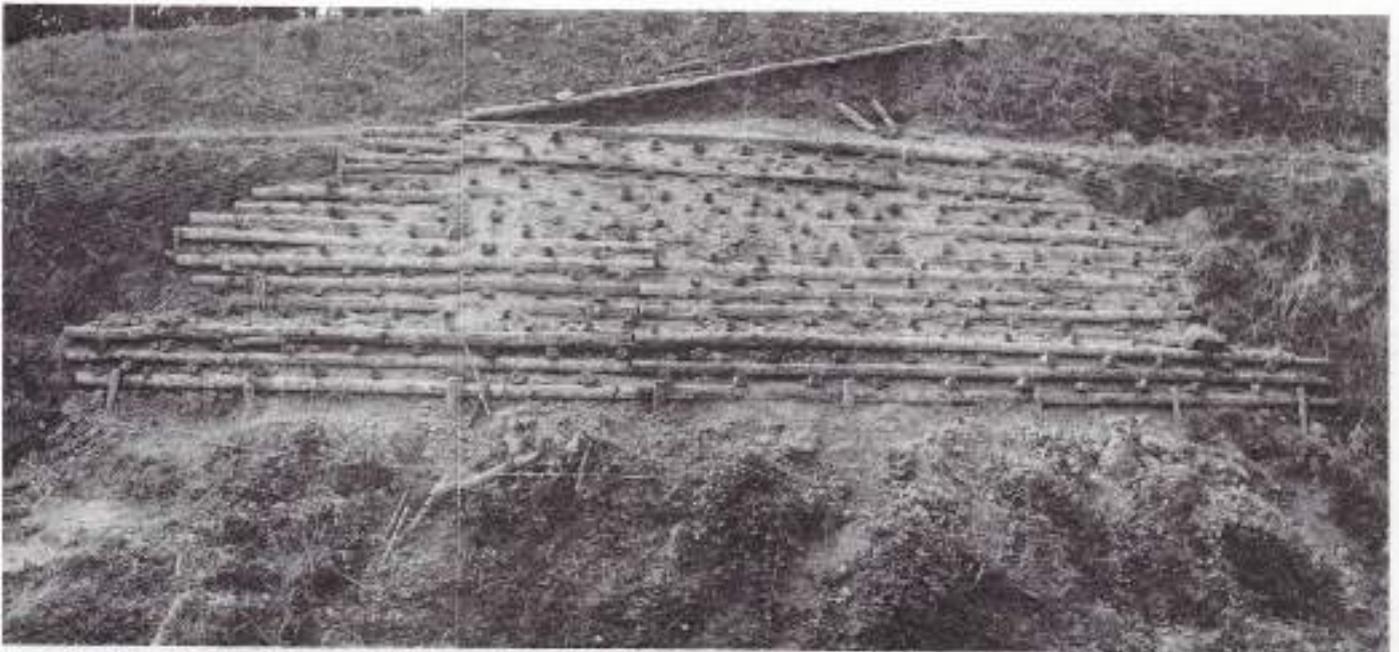
Picture 8.

The above picture shows the completed design of log retaining wall. After completion the wall was seeded with *Calopogonium muconoides* to stabilize the soil.

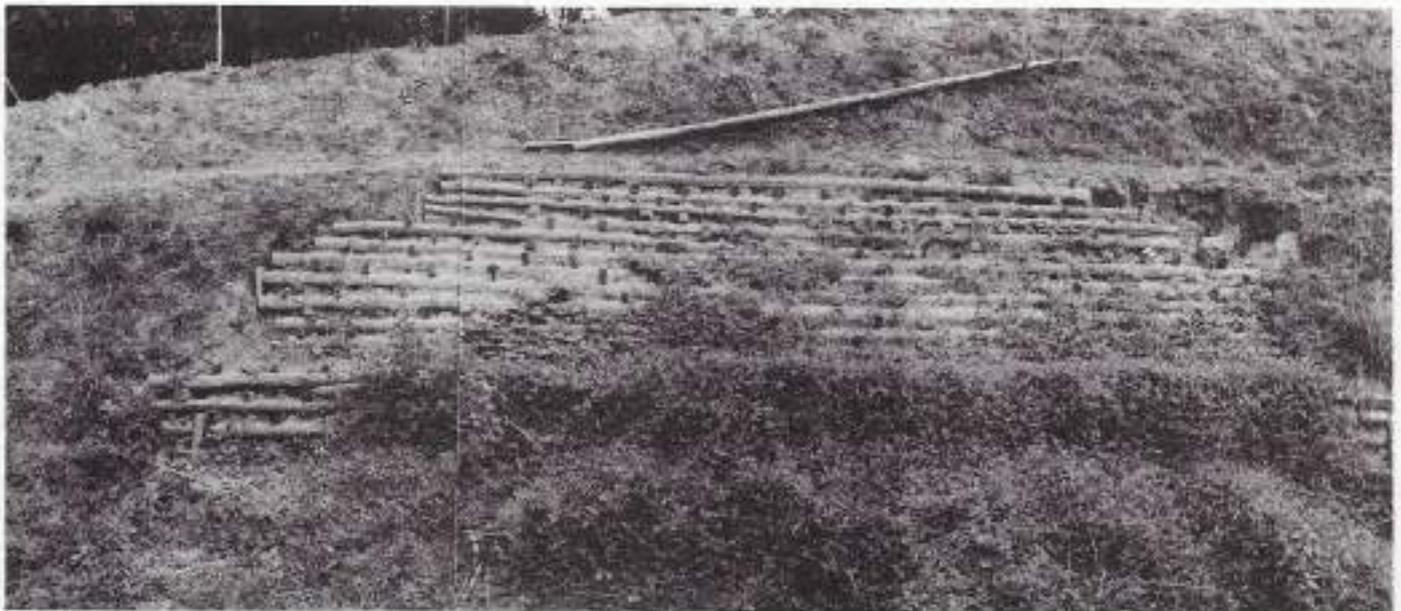
Picture 9 was taken 3 months after seeding. Note that the lower portion of log the retaining wall is almost fully covered with the growth of *Calopogonium muconoides*. Most of the seeds seeded on the top half of the wall were washed down by rain water. This resulted in a much denser growth of *Calopogonium muconoides* on the lower section.

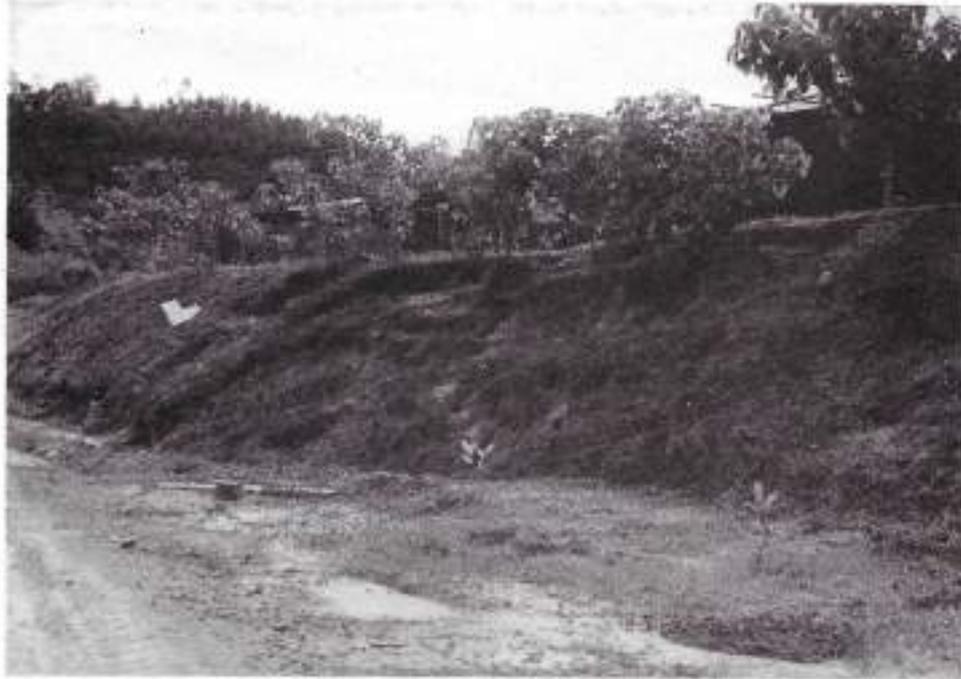
Situation 3. Landslide of a cut slope. (Picture 10).

Possible cause : Gravitational erosion coupled with water erosion.

This damaged area was repaired using old tyres retaining wall. The detail of the design can be referred to the *Manual of Forest Maintenance and Soil Erosion Control* by Jazah Saman and Takeshi Nakamura (1991).

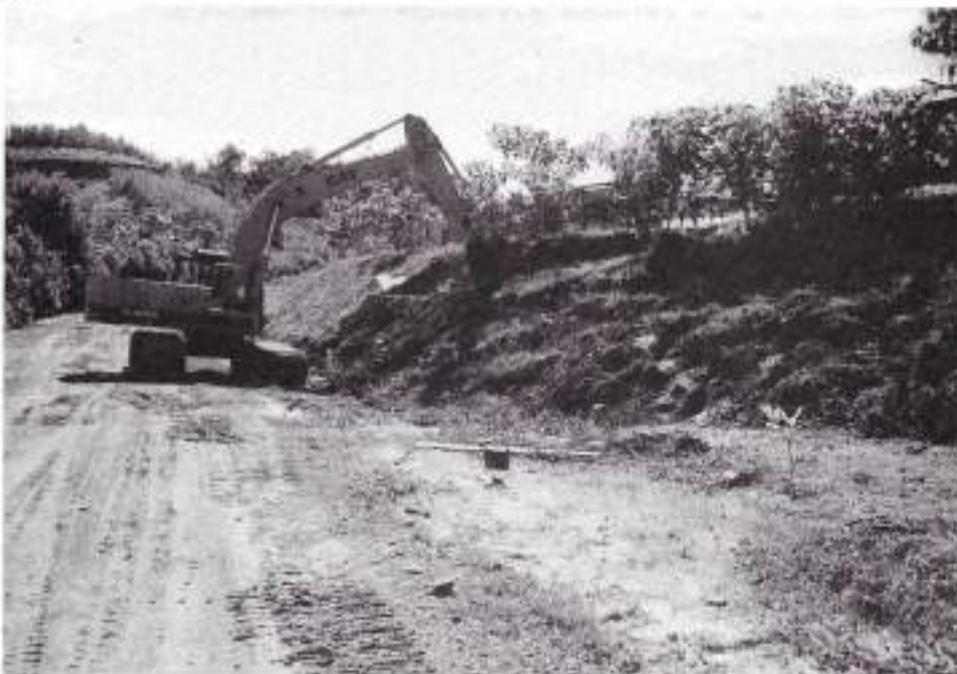
Picture 11.

An excavator was used in reshaping and constructing of a terrace on the damaged area.

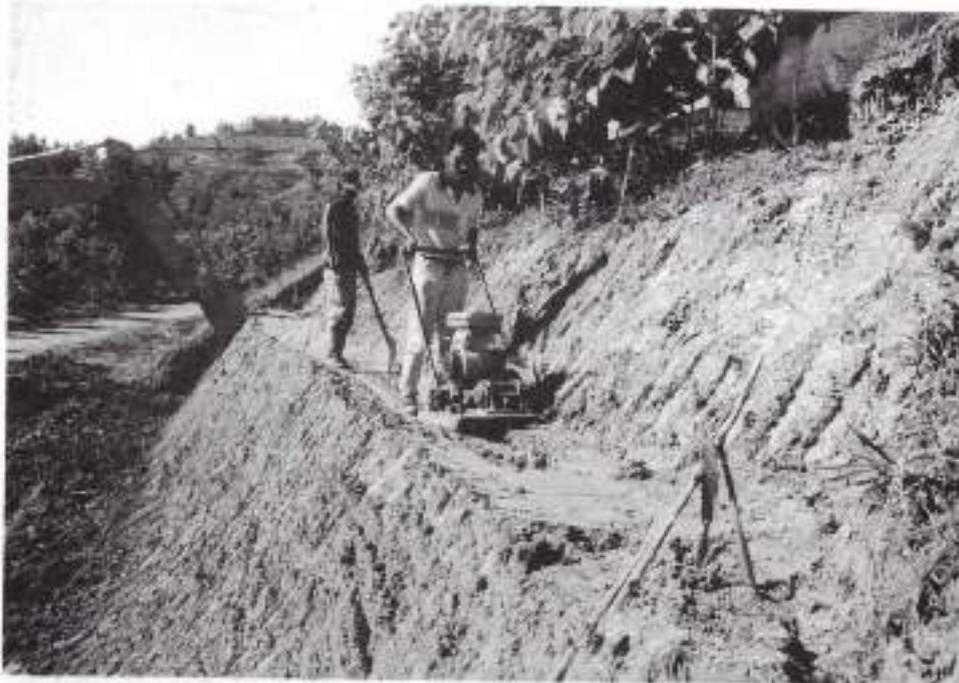
Picture 12.

The terraced section of the new slope surface was compacted with a compactor machine. Note that the slope of the cut area is steeper than the original slope.

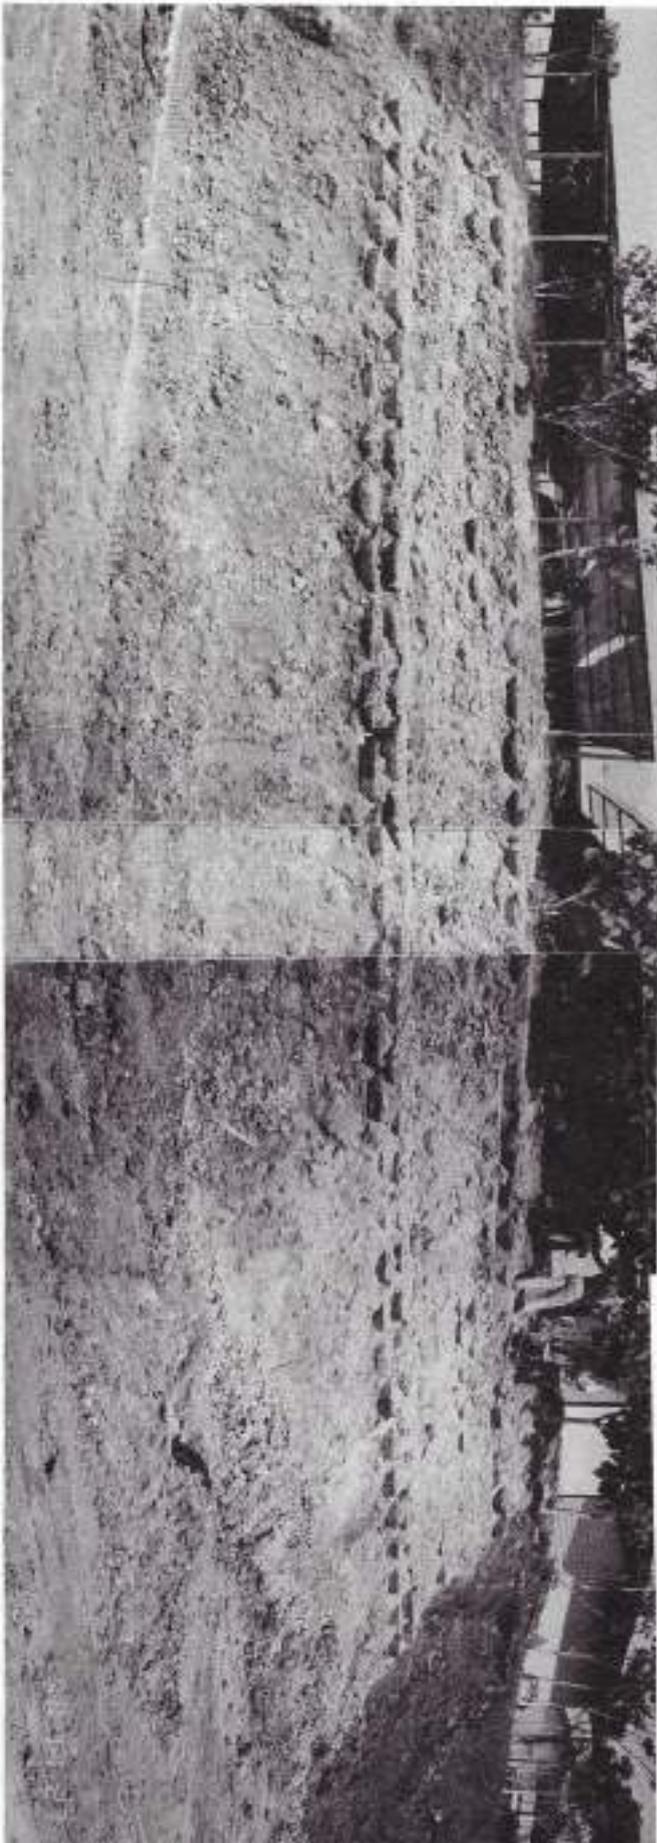
Picture 13.

This picture shows the overall arrangement of the used tyres in the retaining wall design. The tyres are arranged in such a way that they overlapped one another. Only the top half of the repaired area is covered with tyres. The lower section was turred (See next picture).

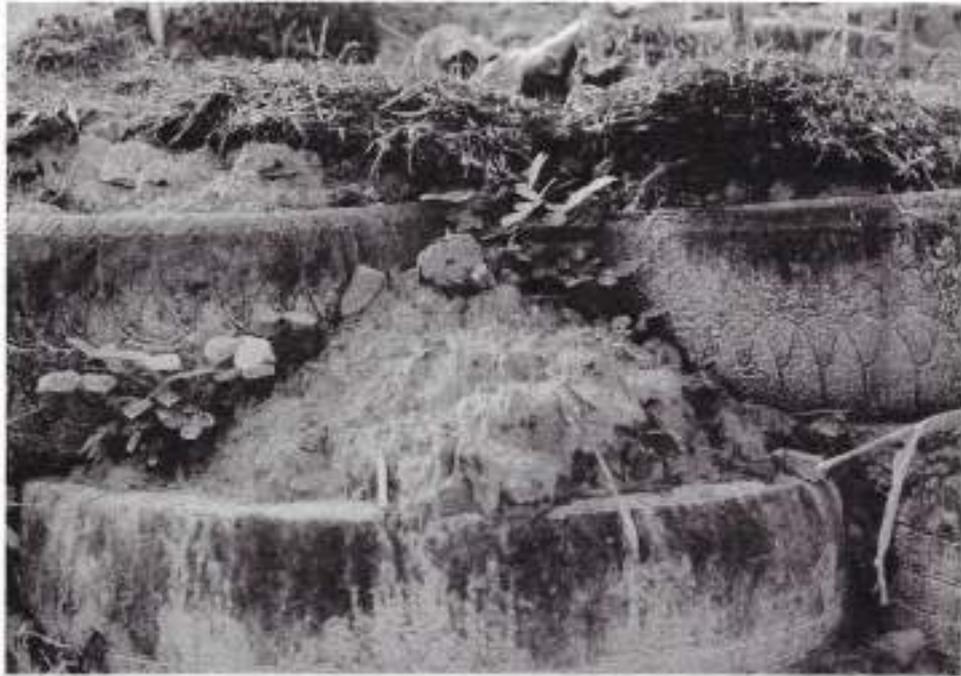
Picture 15.

This picture was taken one month after seeding. It shows the growth of *Calopogonium muconoides*.

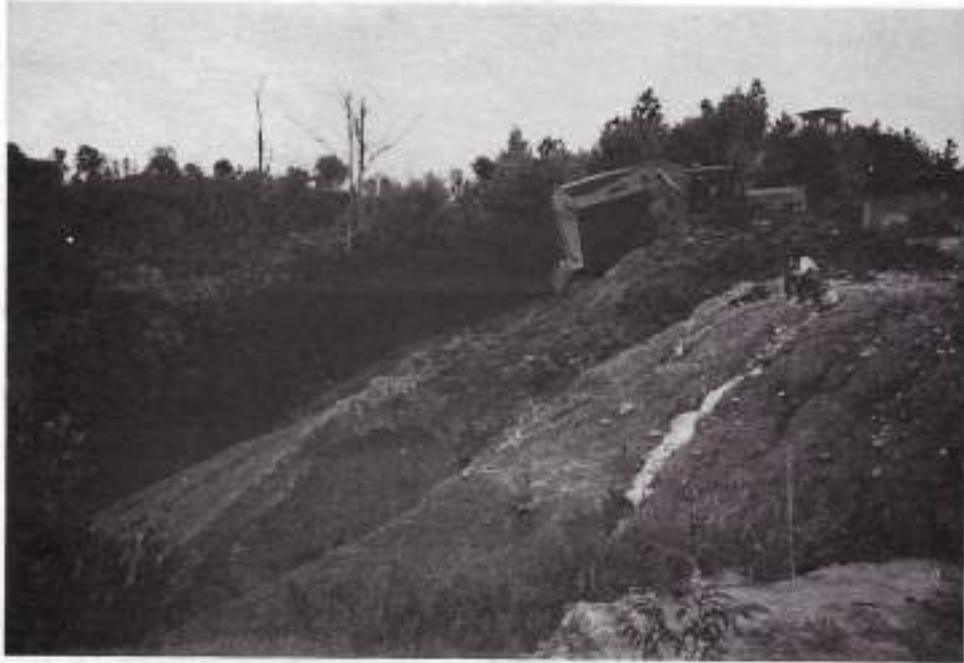
Situation 4. Gully erosion on a filled slope. (Picture 17).

Cause: Water erosion.

Heavy machinery (excavator) was used in repairing and reshaping the damaged area. Repair work was started from the top, a terrace was cut about midway of the damaged area.

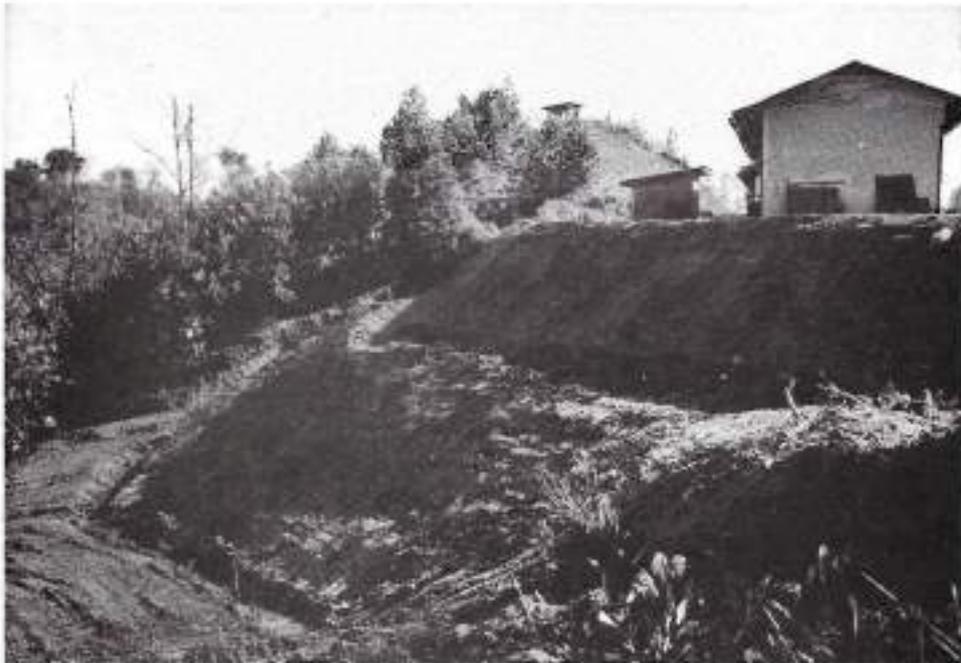
Picture 19 shows the new slope face with a terrace. A drain was also built at the foot of the slope. Picture 19.

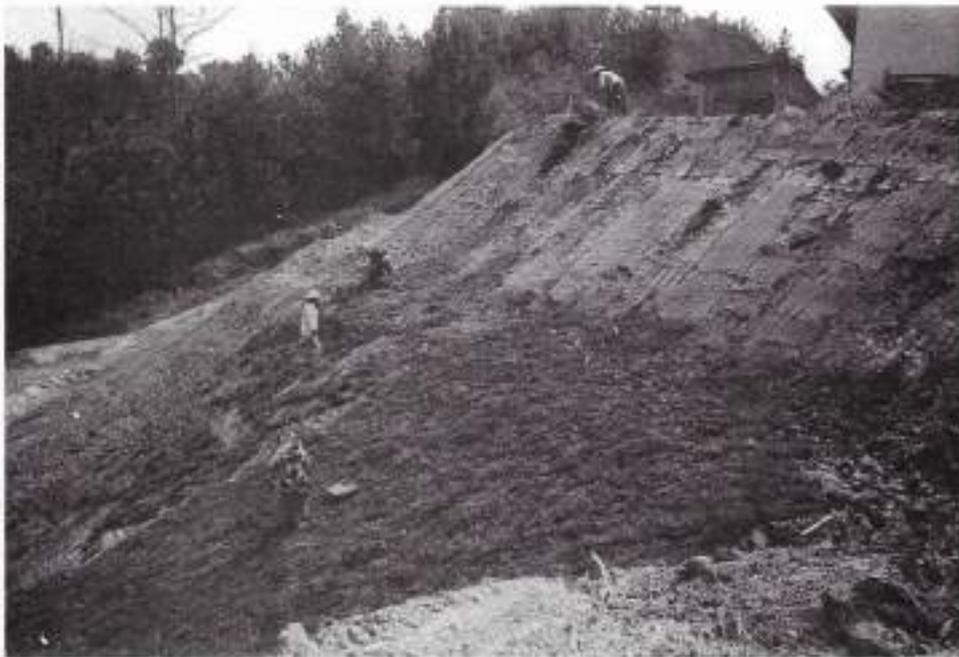
After cutting operation was completed, turbing was done. Grass turfs were arranged starting from the terraced section and downwards. This is done to prevent breaking the grass turfs from pressure exerted by the worker weight. Bamboo pegs were also used to pin the grass turfs. Picture 20.

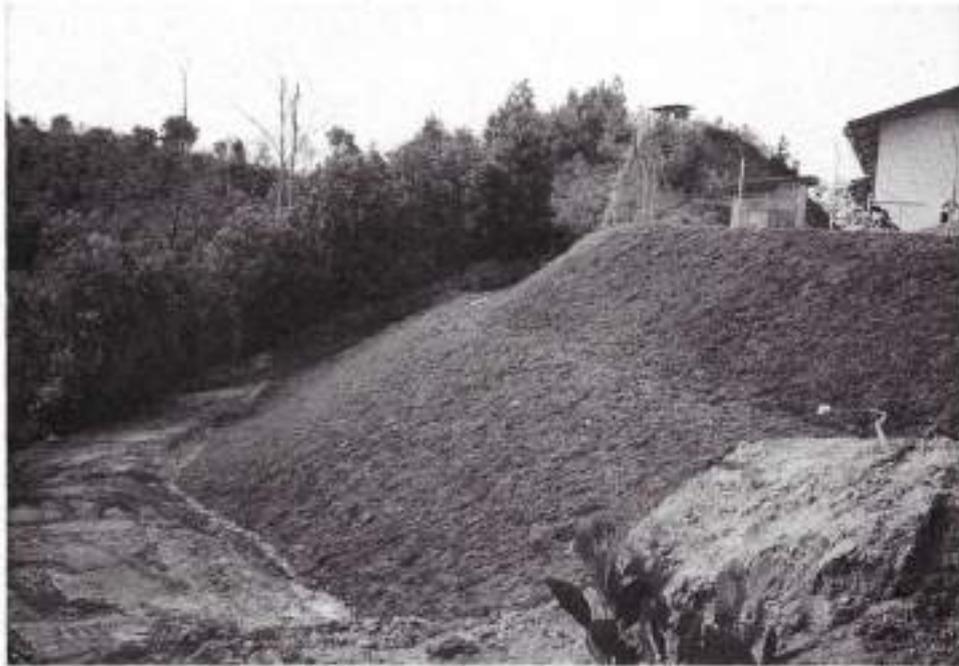
Picture 21.

This picture shows how the damaged area looks like after repair.

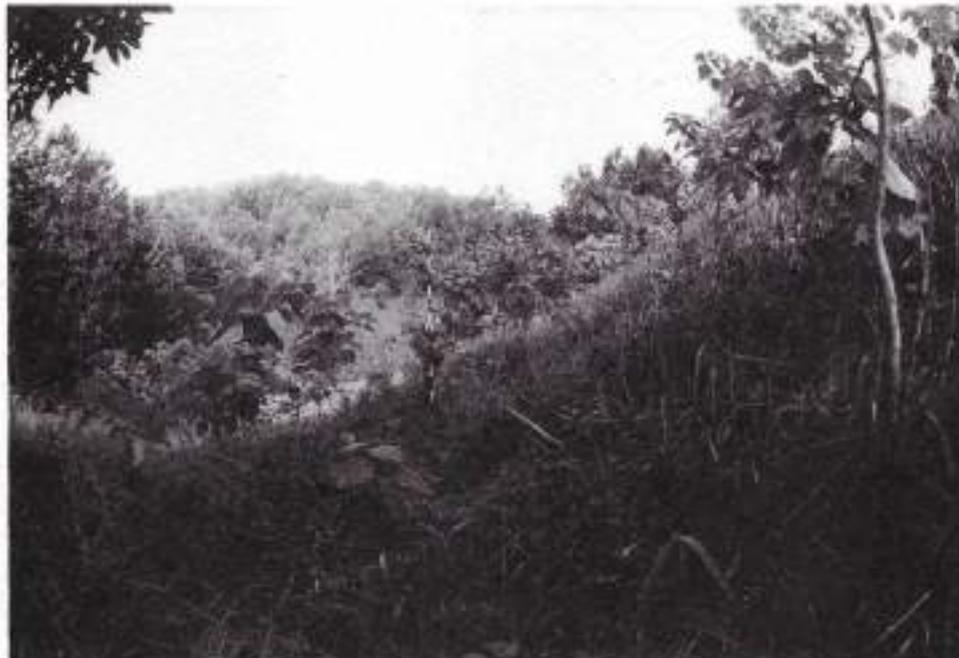
Picture 22.

Picture 22 of the same area was taken two years later. Note the dense growth of the grasses. This area was also planted with *Gmelina arborea* to further stabilize the soil.

Current observation: The repaired area has stabilized.

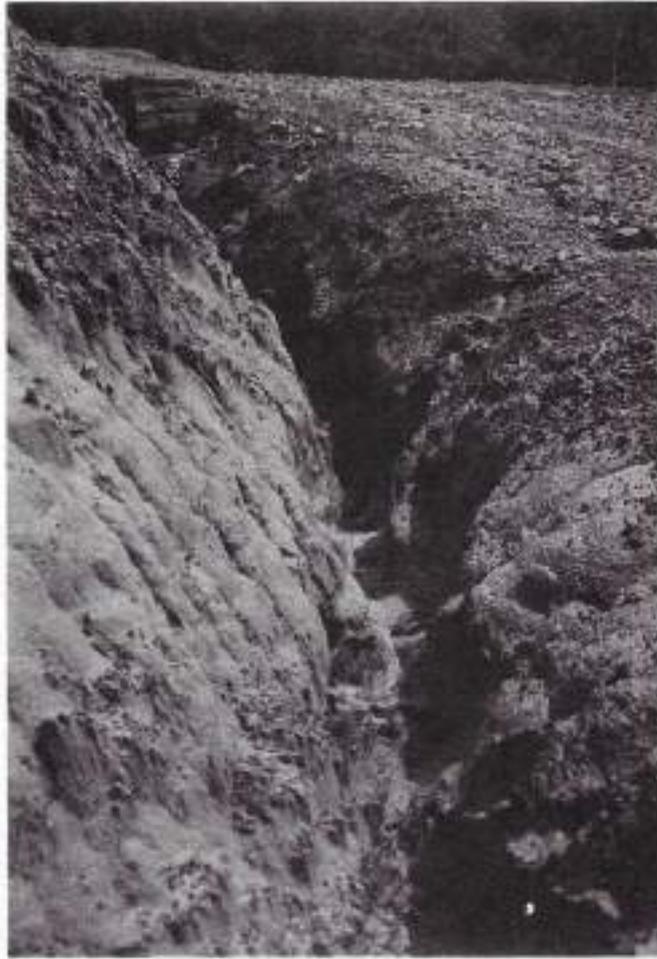
Picture 23.

Situation 5. Highly eroded side drain on steep road side.

Cause: Fast flowing and highly erosive water.

This damaged drain was repaired by constructing a concrete box in the drain so as to block the flow of water. The collected water is then discharged through a culvert to the other side of the road.

Drain section downhill from the concrete box was filled with soil and sandbags were arranged so as to further reduced the flow of water.

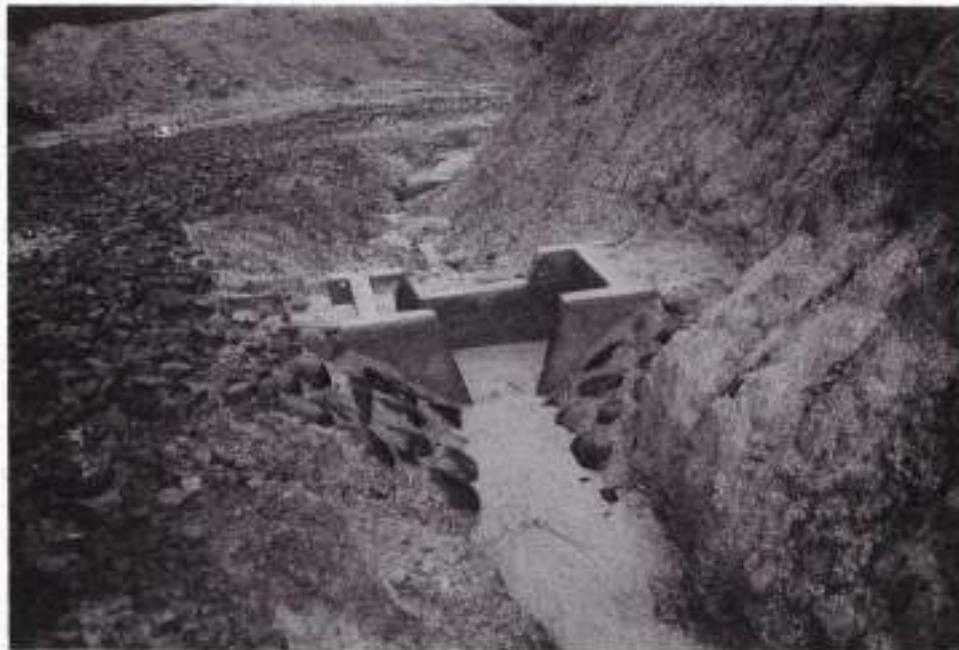
Picture 26. It can be seen in this picture, the amount of water flow behind the concrete box has been highly reduced compared with the front. The concrete box greatly helped reduce the severity of water erosion on the drain.

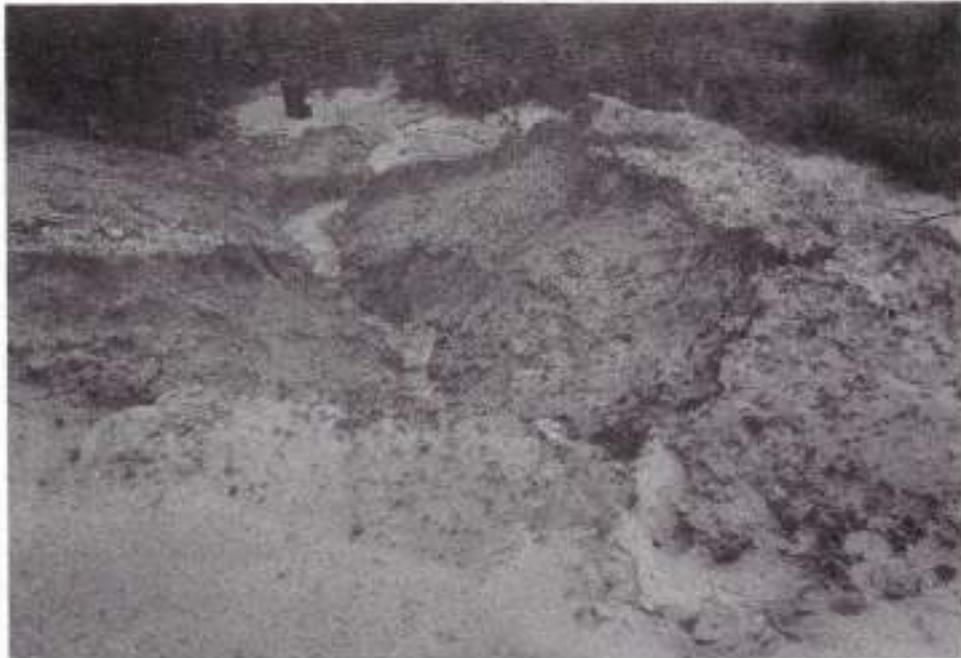
Picture 28.

Situation 6. Gully erosion on steep slope.

Cause: Fast flowing and highly erosive water.

This damaged area was first repaired by filling up the gully with soil. After that a tentative drain using plastic sheet was constructed. See picture below. Filled sandbags were put on both sides of the drain's mouth to direct the flow of water into the drain.

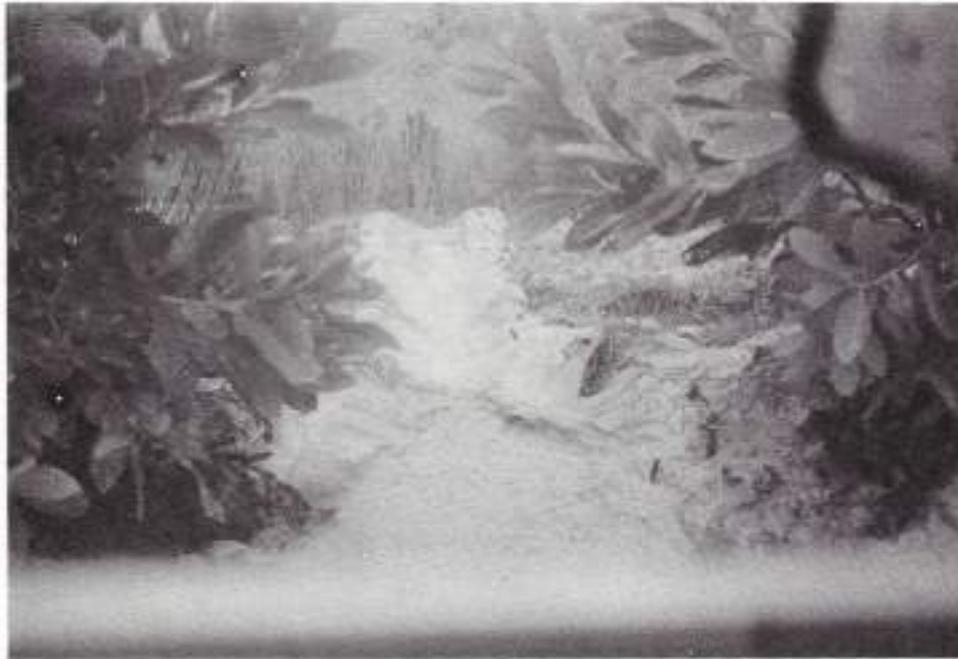
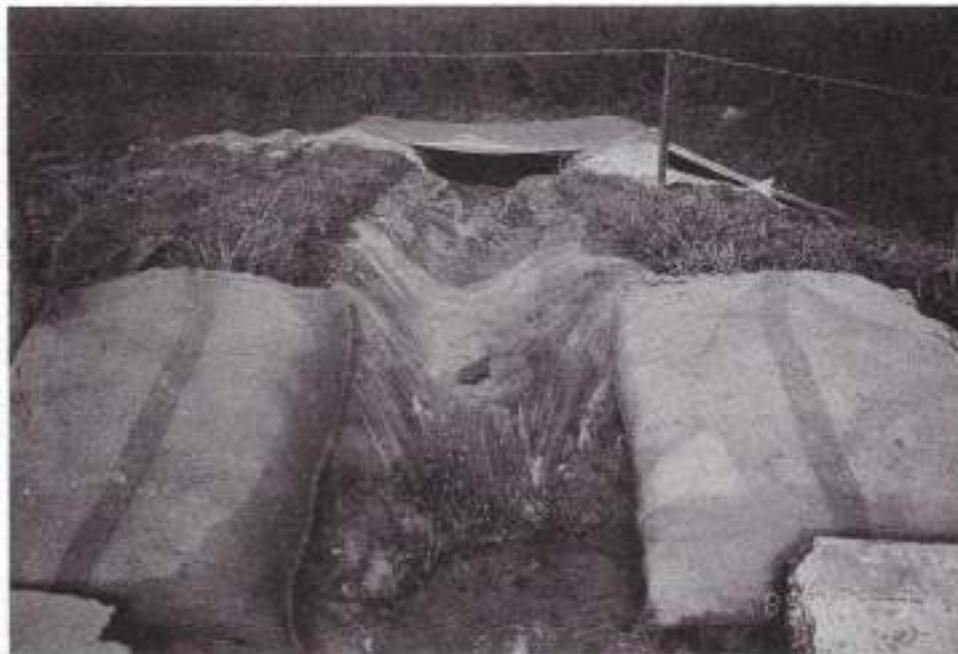
Picture 29.

Large plastic sheet (in the picture - green colour) was used to cover the filled-up section of the gully to prevent more damages cause by rain water. Some section was turfed.

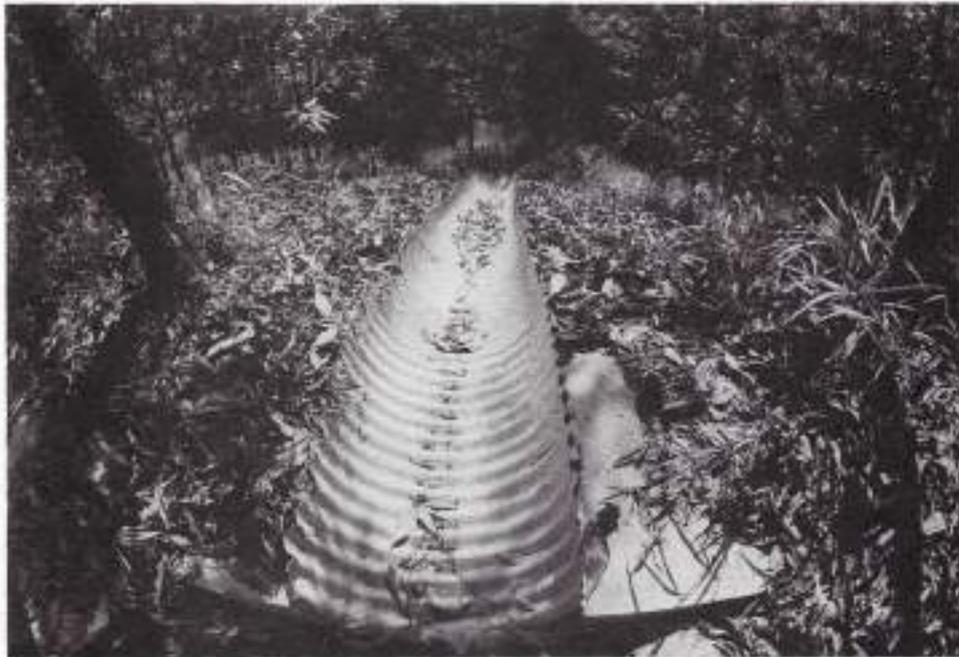
Picture 30.

A permanent drain of corrugated pipes was installed a couple of months later. In the picture below, it shows the present situation of the area. Grasses have grown and trees had been planted. Current observation: the area has stabilized.

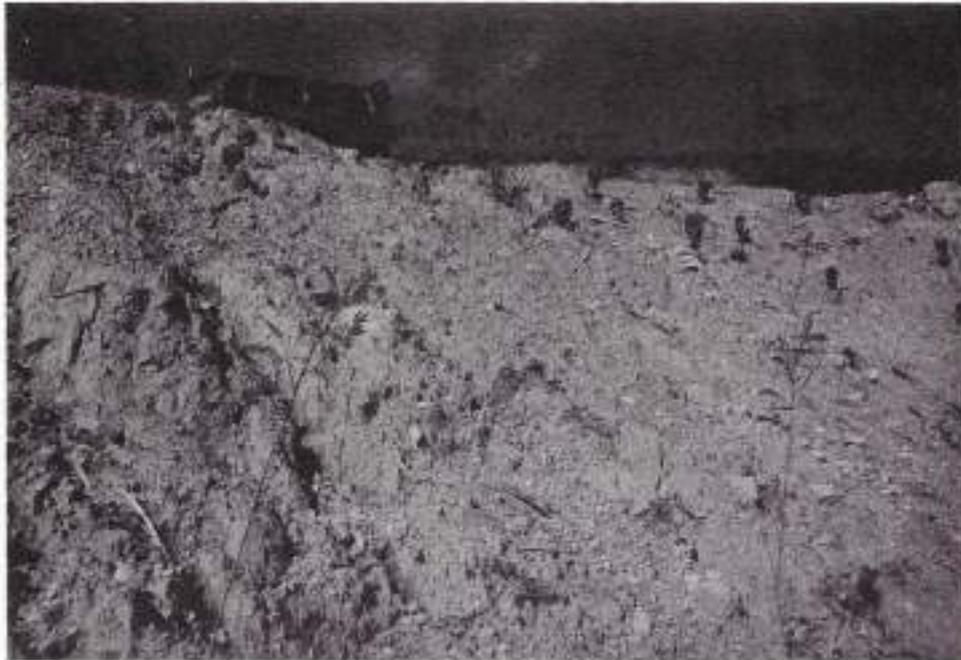
Picture 31.

This filled-slope was initially stabilize by planting trees (species *Gmelina arborea*). The above picture was taken 6 months after planting. Picture 32 of the same area was taken 2 years later. Most of the trees have grown over 2 meters. Grasses have also invaded the area.

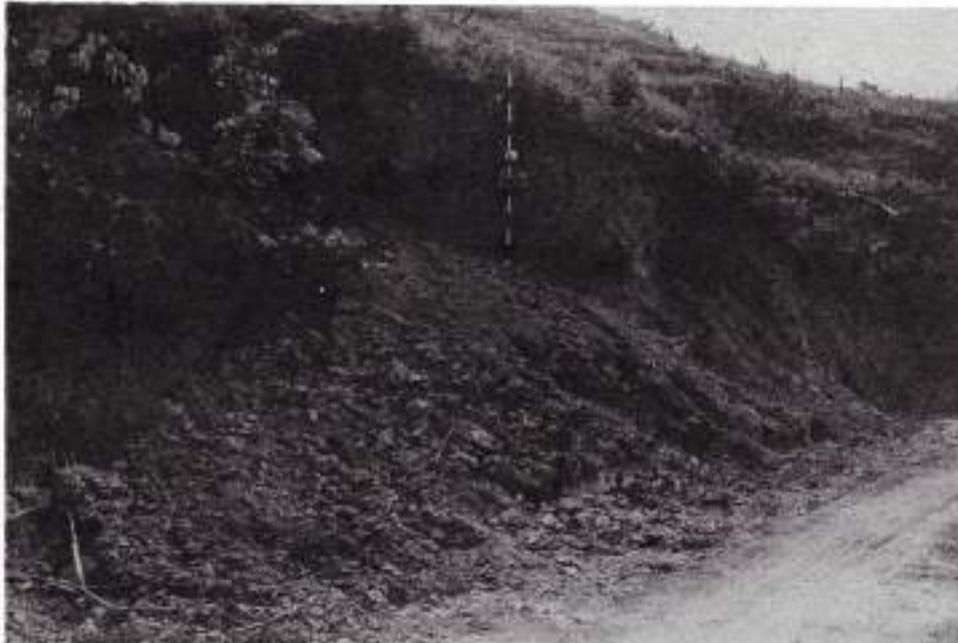
Picture 33.

Situation 8. Collapse of cut slope of forest road.

Possible cause(s) : Gravitational erosion combined with water erosion.

This damaged area was repaired using tyres retaining wall. Wall design can be referred to the *Manual of Forest Road Maintenance and Soil Erosion Control* by Jazah Saman and Takeshi Nakamura (1991).

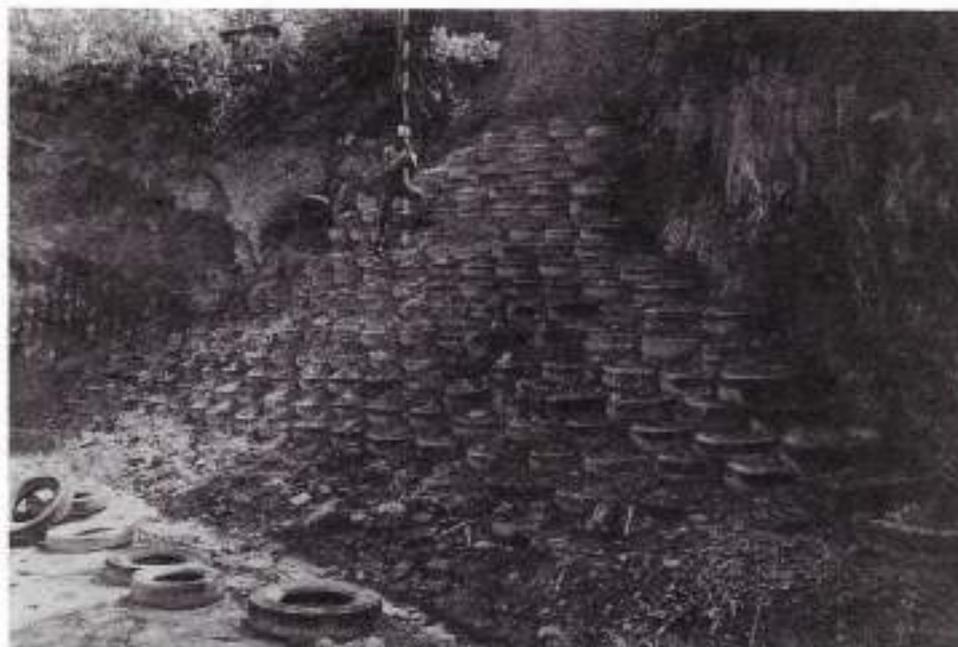
Picture 34.

Picture 34 shows the completed tyres retaining wall. The retaining wall was also seeded with *Calopogonium muconoides*. Observation is still being carried out on the effectiveness of this design.

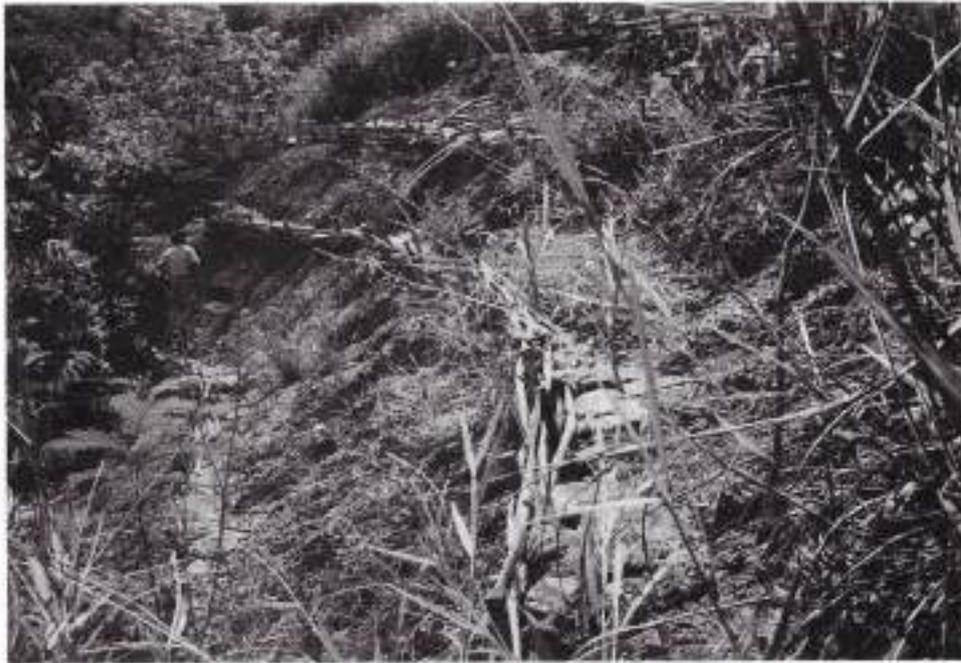
Picture 35.

Situation 9. Gully (moderate size) erosion on road fill slope.

Bamboo wattling fence was used in the stabilization of the slope. Detail of design can be referred to the *Manual of Forest Road Maintenance and Soil Erosion Control* by Jazah Saman and Takeshi Nakamura (1991). As can be seen in the picture, sandbags were also placed along side of the fencing. The aim of these sandbags is to reduce the velocity of run off water.

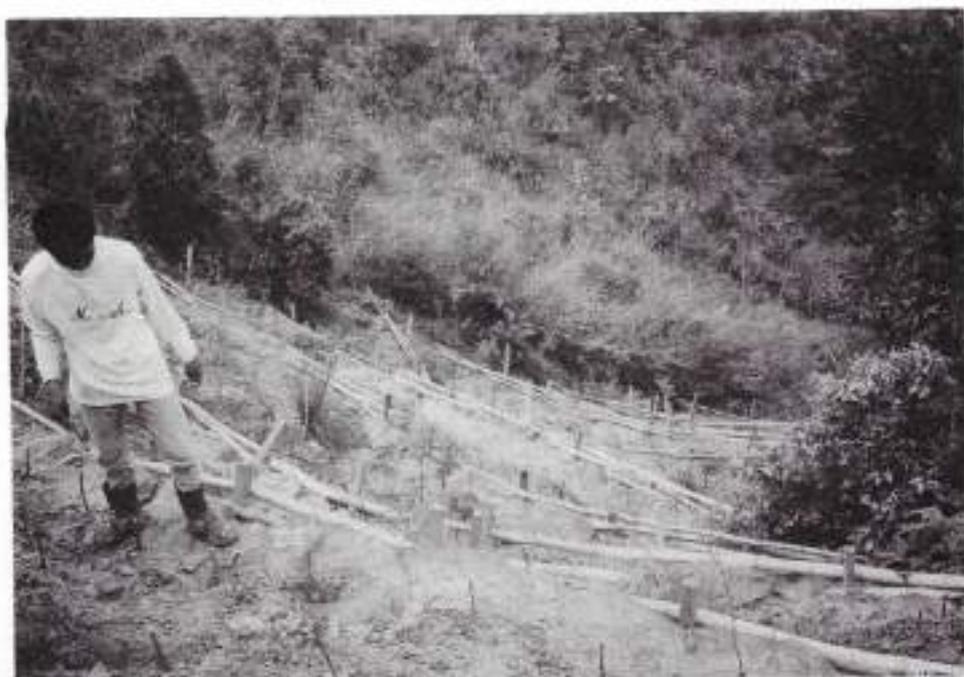
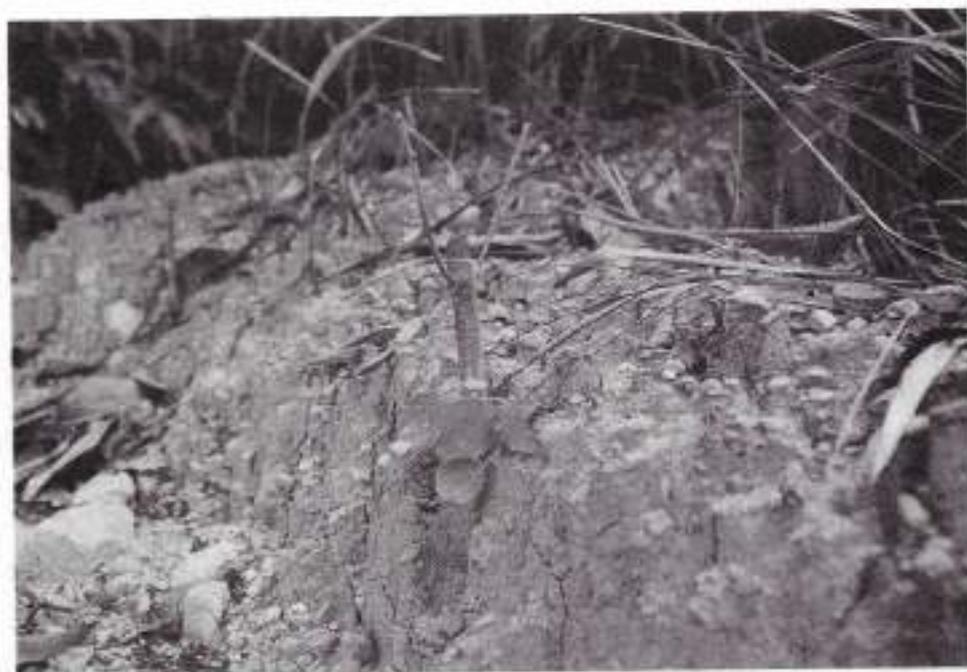
The area was also planted with *Gmelina arborea* cutting. See Picture 36.

Observation on the area is still going on.
