SOIL EROSION STABILIZATION IN KINARUT PROJECT

Reported by:
Jazah Saman
Plantation Officer, SAFODA

JULY 1992

**Sabah Re-Afforestation Technical Development
And Training Project**

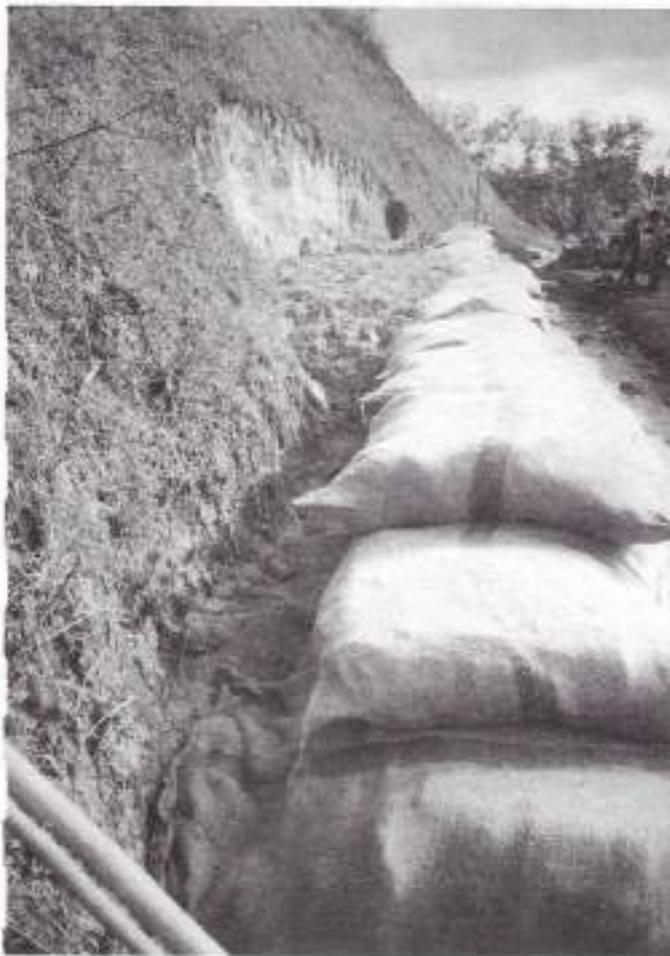
This method of slope repair can be carried out easily. The only drawback to this method is the lack of material durability. Gunny sacks when exposed to the forces of nature can only last for a few months. (See Picture 5).

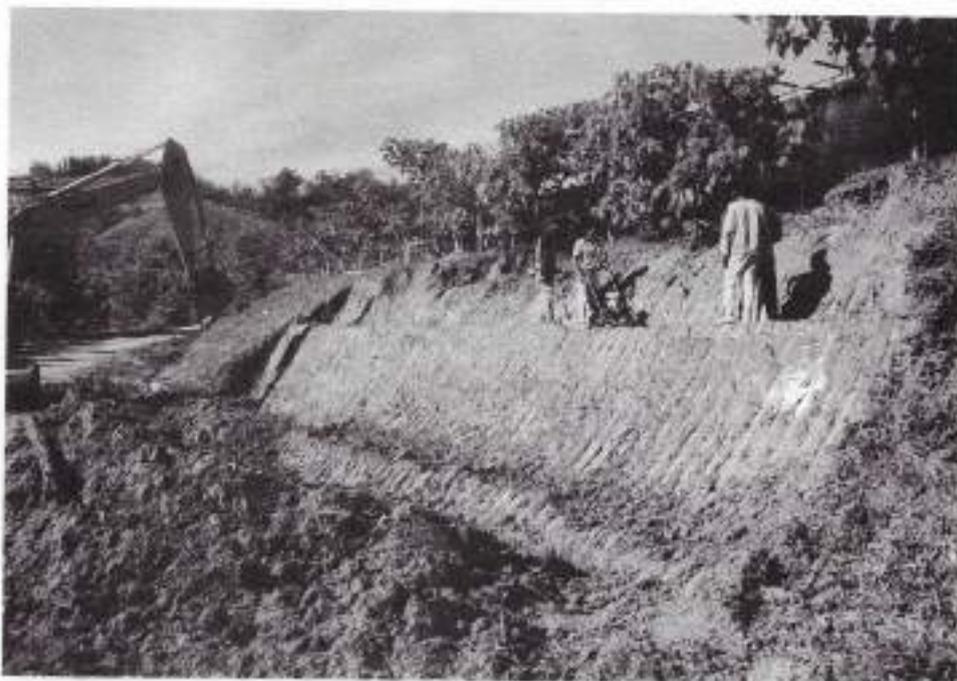
Picture 13.

The terraced section of the new slope surface was compacted with a compactor machine. Note that the slope of the cut area is steeper than the original slope.

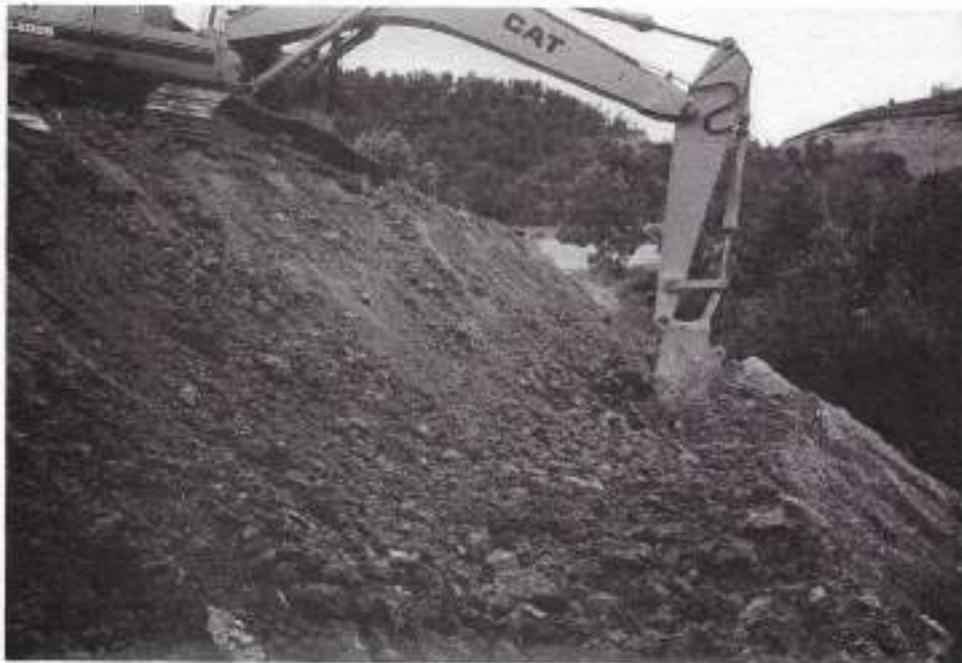
Picture 18.

Heavy machinery (excavator) was used in repairing and reshaping the damaged area. Repair work was started from the top, a terrace was cut about midway of the damaged area.

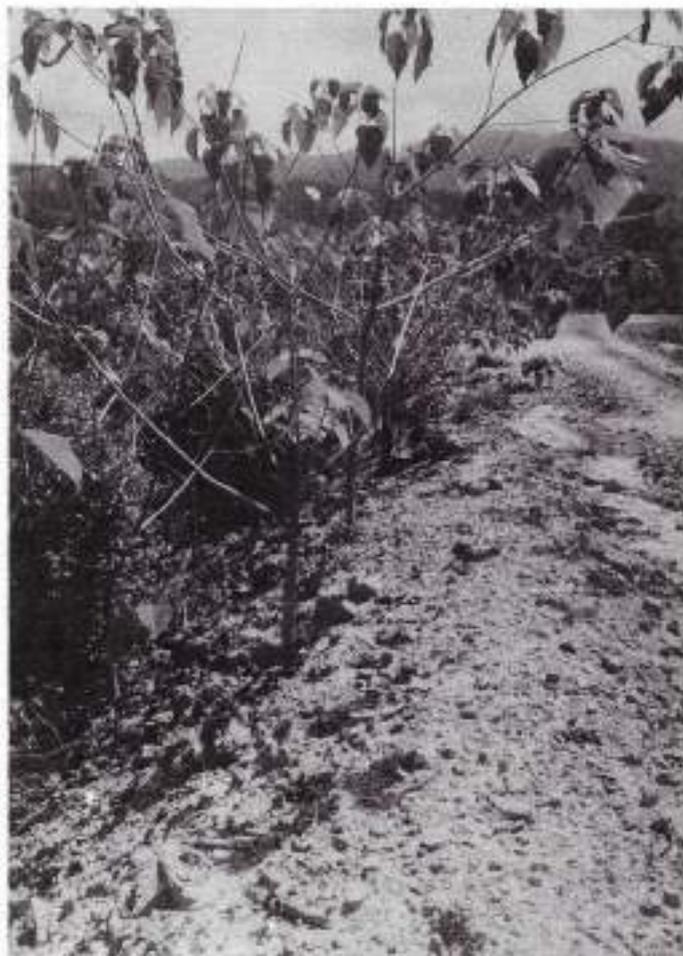
This filled-slope was initially stabilize by planting trees (species *Gmelina arborea*). The above picture was taken 6 months after planting. Picture 32 of the same area was taken 2 years later. Most of the trees have grown over 2 meters. Grasses have also invaded the area.
